Manhole Inspection Summary

Manhole # S33Q__007MH

Insp Date: **2/5/08 12:01 PM**

Location Address: **s.howard st**

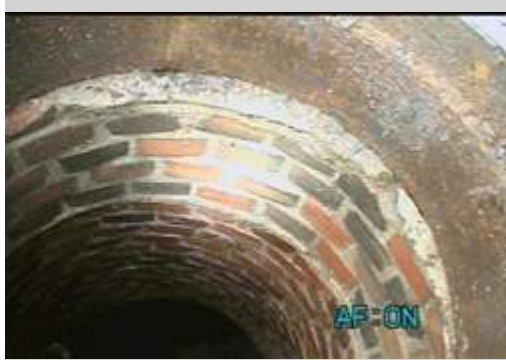
Defect 2

Offset: **1** (in.)

Frame offset 1"

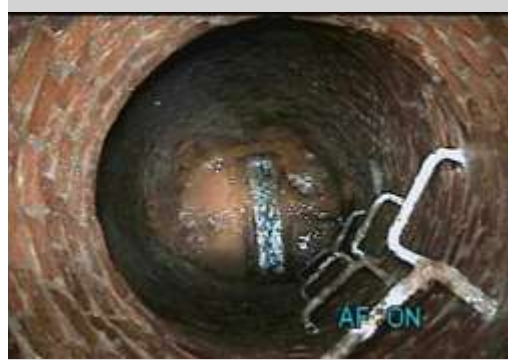
Defect 1

Count: **12** Missing: **0** ☒ **Corroded**

Corroded Steps, Bench Deteriorated,
Bench Debris

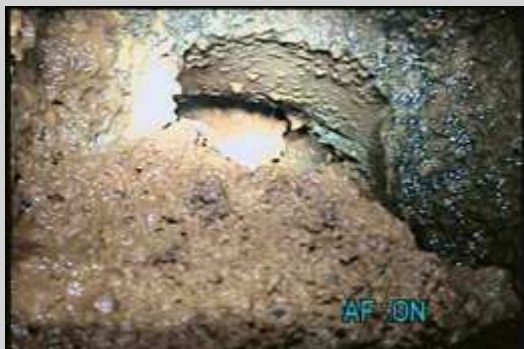
3 O'Clock Inflow

8 in. Circular Gravity Sewer
Pipe In @ 3 O'Clock

Deposits: ☐ None ☒ **Mud** ☒ **Sludge** ☐ Debris ☐ Grease

Silt Depth: 7 (in.) Deposits Extent: **Heavy**
